# Your site inspection

A look inside a real report

ANONYMISED REPORT EXCERPT

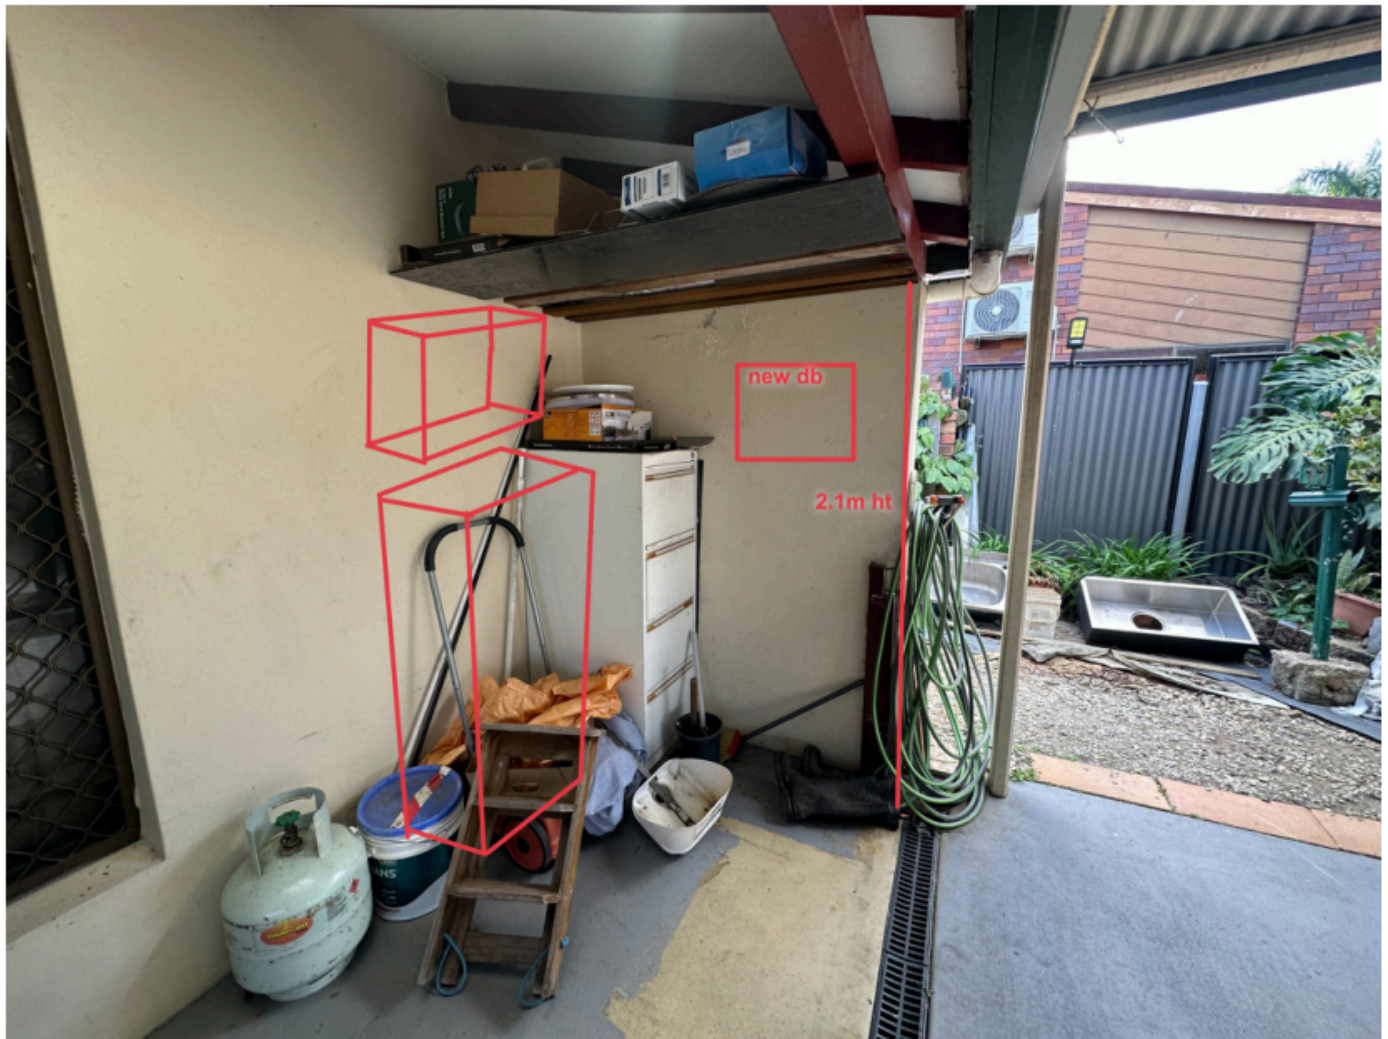
## 01 Proposed equipment location

A marked-up site photograph shows the proposed battery, inverter and distribution-board positions.

- 2.1m ht
- new db

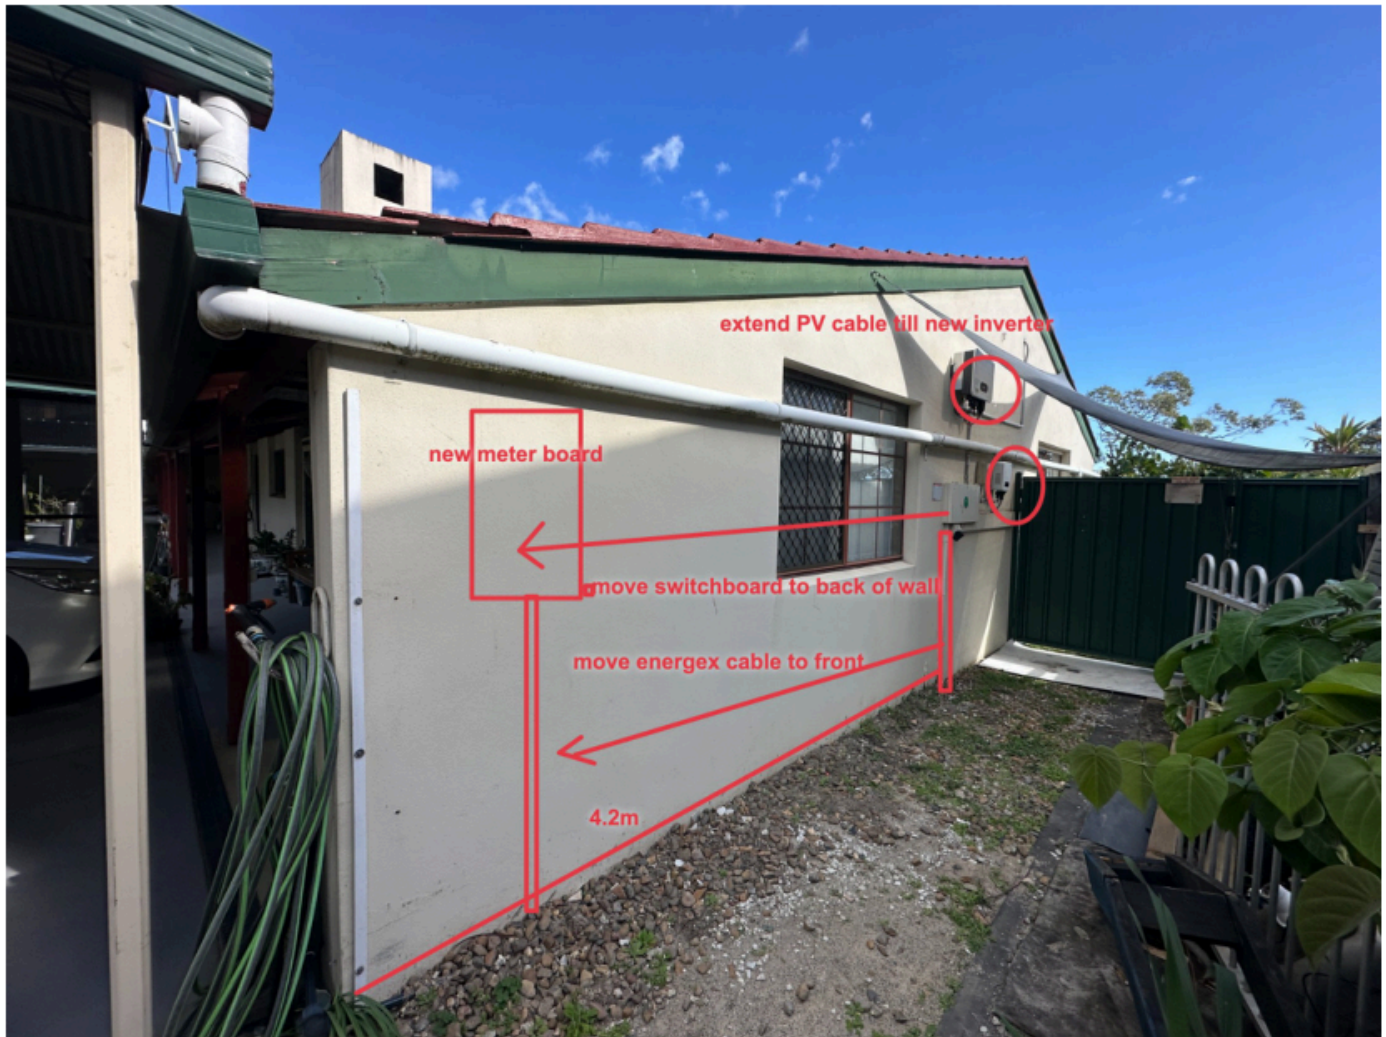
## 02 Cable routes and site work

A second photograph records proposed board relocation and cable extensions.

- move switchboard to back of wall
- move energex cable to front
- extend PV cable till new inverter
- 4.2m
- new meter board
